TECHNICAL ASSISTANCE TEAM FOR EMERGENCY RESPONSE REMOVAL AND PREVENTION
EPA CONTRACT 68-01-6669

SUBJECT: Site Assessment at W.J. Smith Wood Preserving Company,
Denison, Texas

TDD#: 06-8503-16

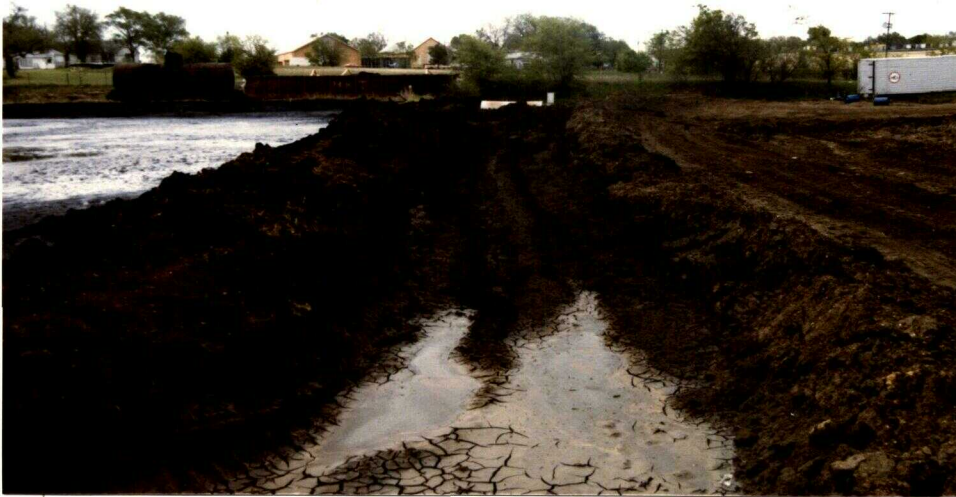
Photographer/Witness # 1

Comments: DOUBLE DIKE AROUND

LAGOONS WITH REFUELING

LANE TO CONTROL CONTAM-

INATION ON HEAVY EQUIPMENT

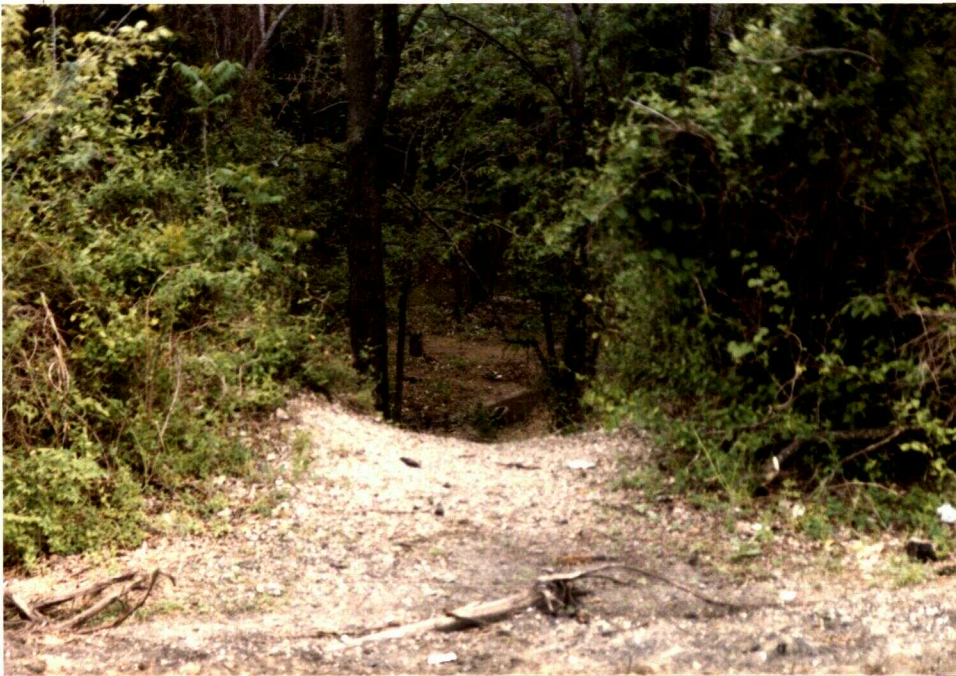
2

Comments: DROP OFF TO THE

SOUTH OF LAGOONS WHERE

SMALL CREEK IS FLOWING

IN SOUTHEAST DIRECTION

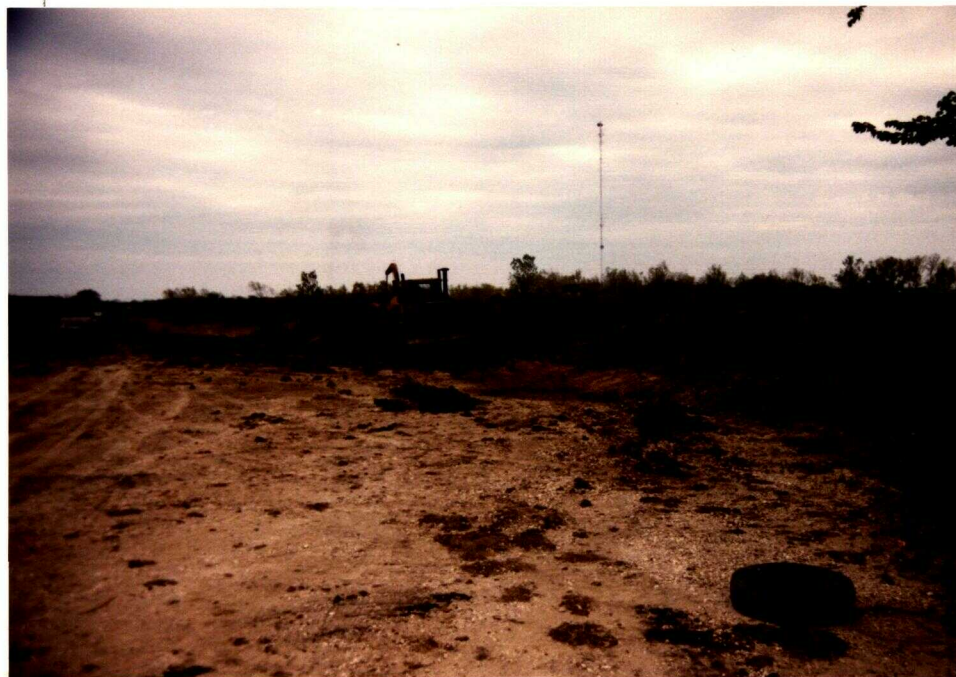
3

Comments: STAGING AREA

WHERE CONTAMINATED SOIL

FROM PROJECT THREE IS

BEING STORED TEMPORARILY

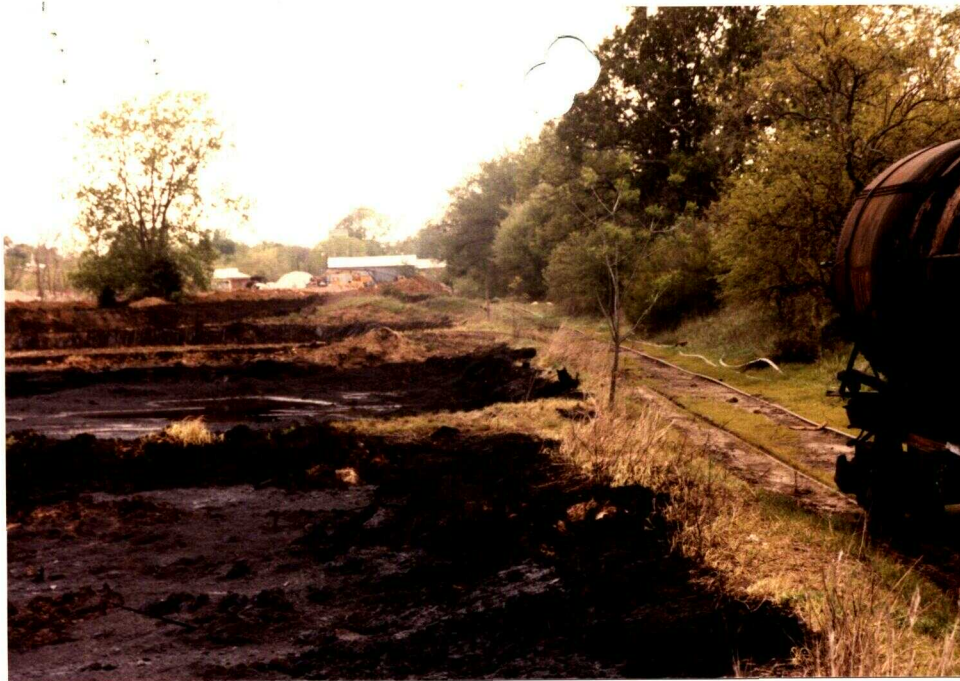
Photo. ographer/Witness # 4

Comments: NORTHERN MOSE EDGE

OF LAGOONS WITH OLD

RAILROAD BED ALONG THE

NORTH EDGE.

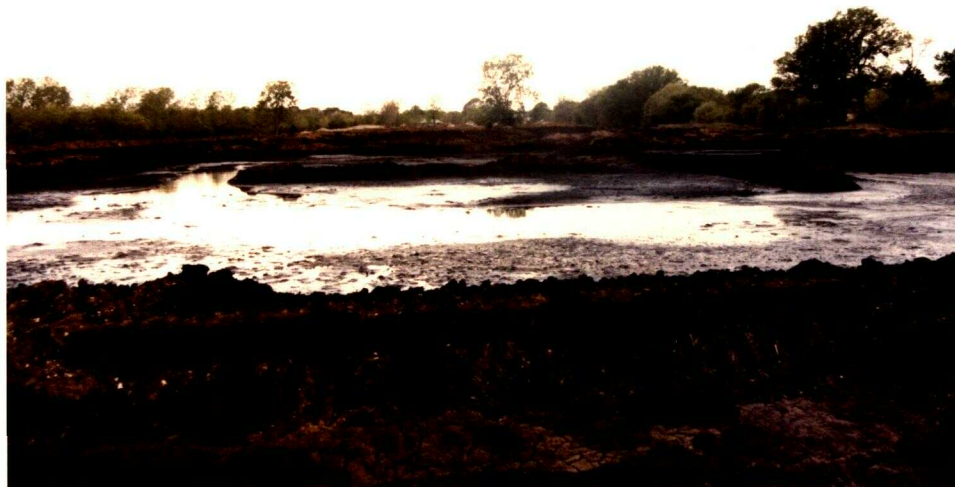
Photographer/Witness # 5

Comments: LAGOONS WHICH

ARE NOW COMBINED INTO

TWO LARGE DRYING

AREAS.

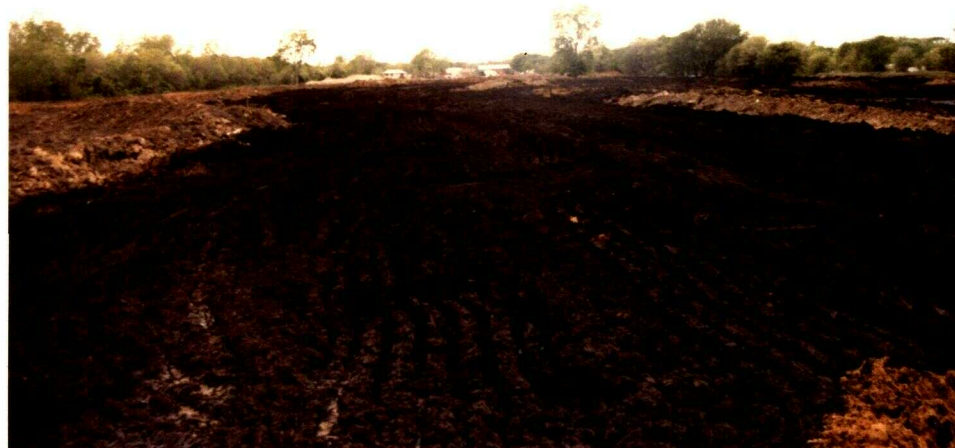
Photographer/Witness # 6

Comments: EXCAVATED SLUDGE,

SOIL MIXTURE FROM LAGOON

MIXTURE IS DRYING OUT

PRIOR TO ADDITIONAL MIXING

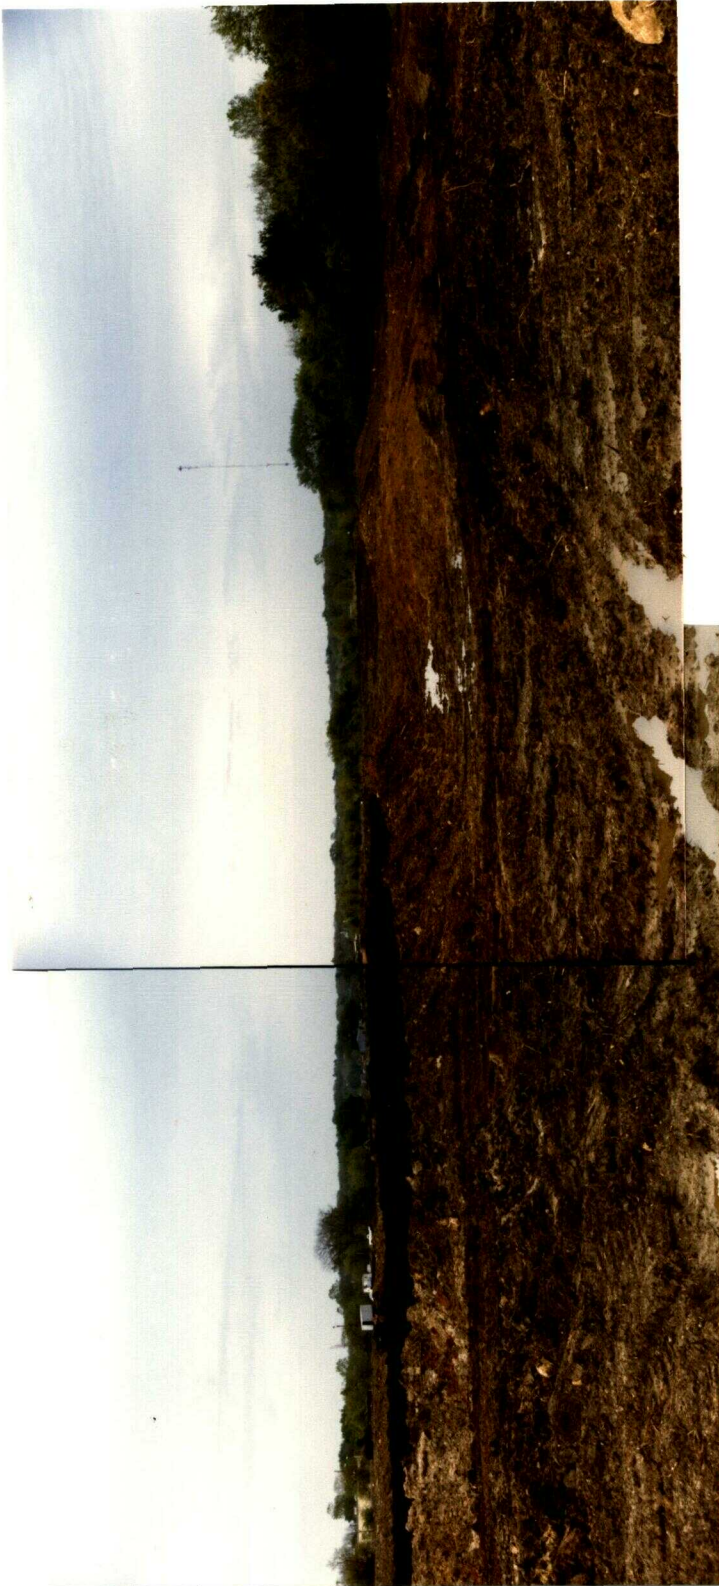
Photo. Grapher/Witness # 7

Comments: PANORAMA OF CREEK
BED TO SOUTH, OPEN FLAT
GROUND, DOUBLE DIKES AROUND
DRYING SLUDGES, + LAGOONS ON
TAT-06-F- THE NORTH SIDE
08701

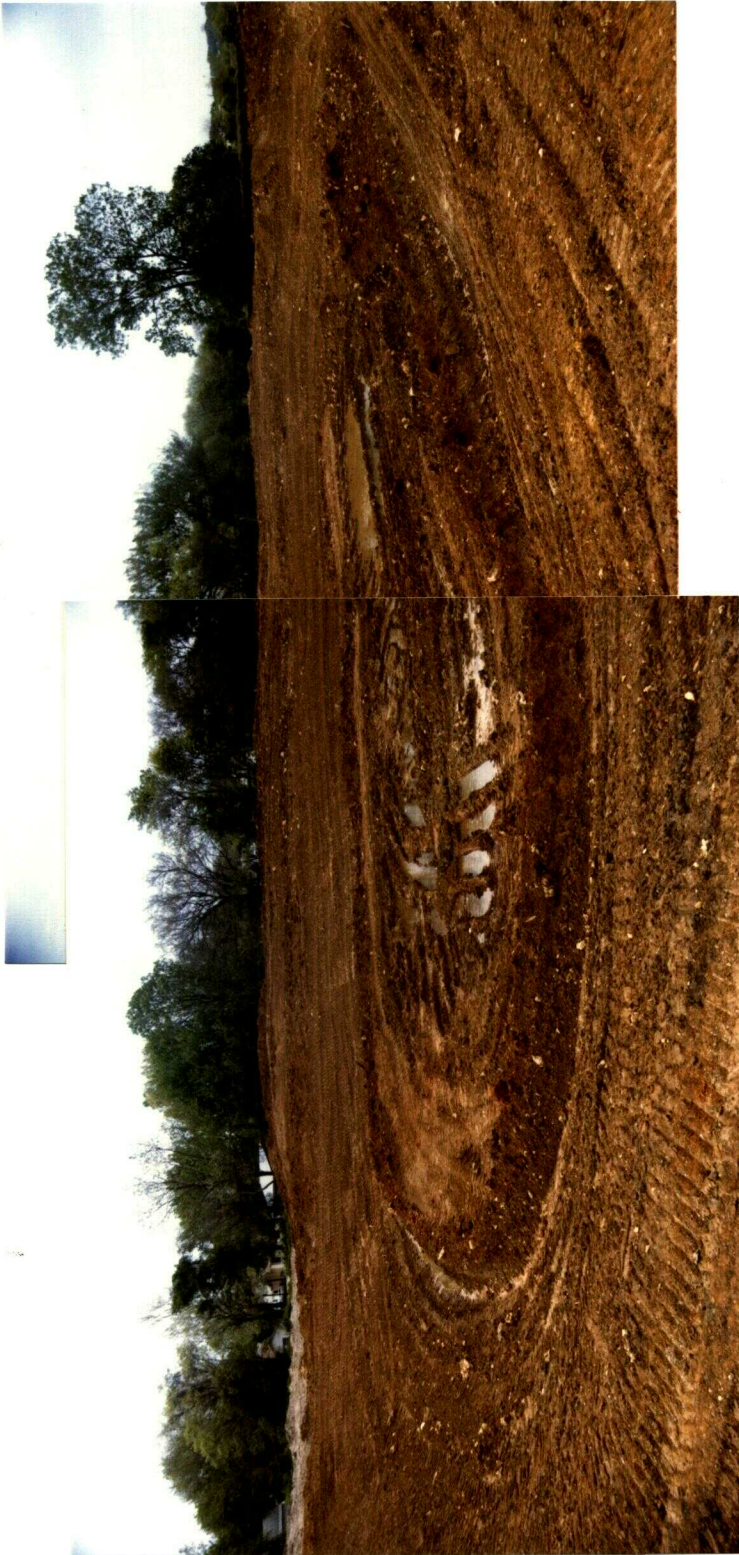
Photo Grapher/Witness # 8BOND / WOODS

4/10/85, 1409 HRS, NORTHComments: LARGE CLAY LINEDCLOSURE PIT ON WEST ENDOF LAGOONS. A FEW MOREFEET TO BE EXCAVATED PRIORTAT-06-F- TO FINISHING THE PIT
08702

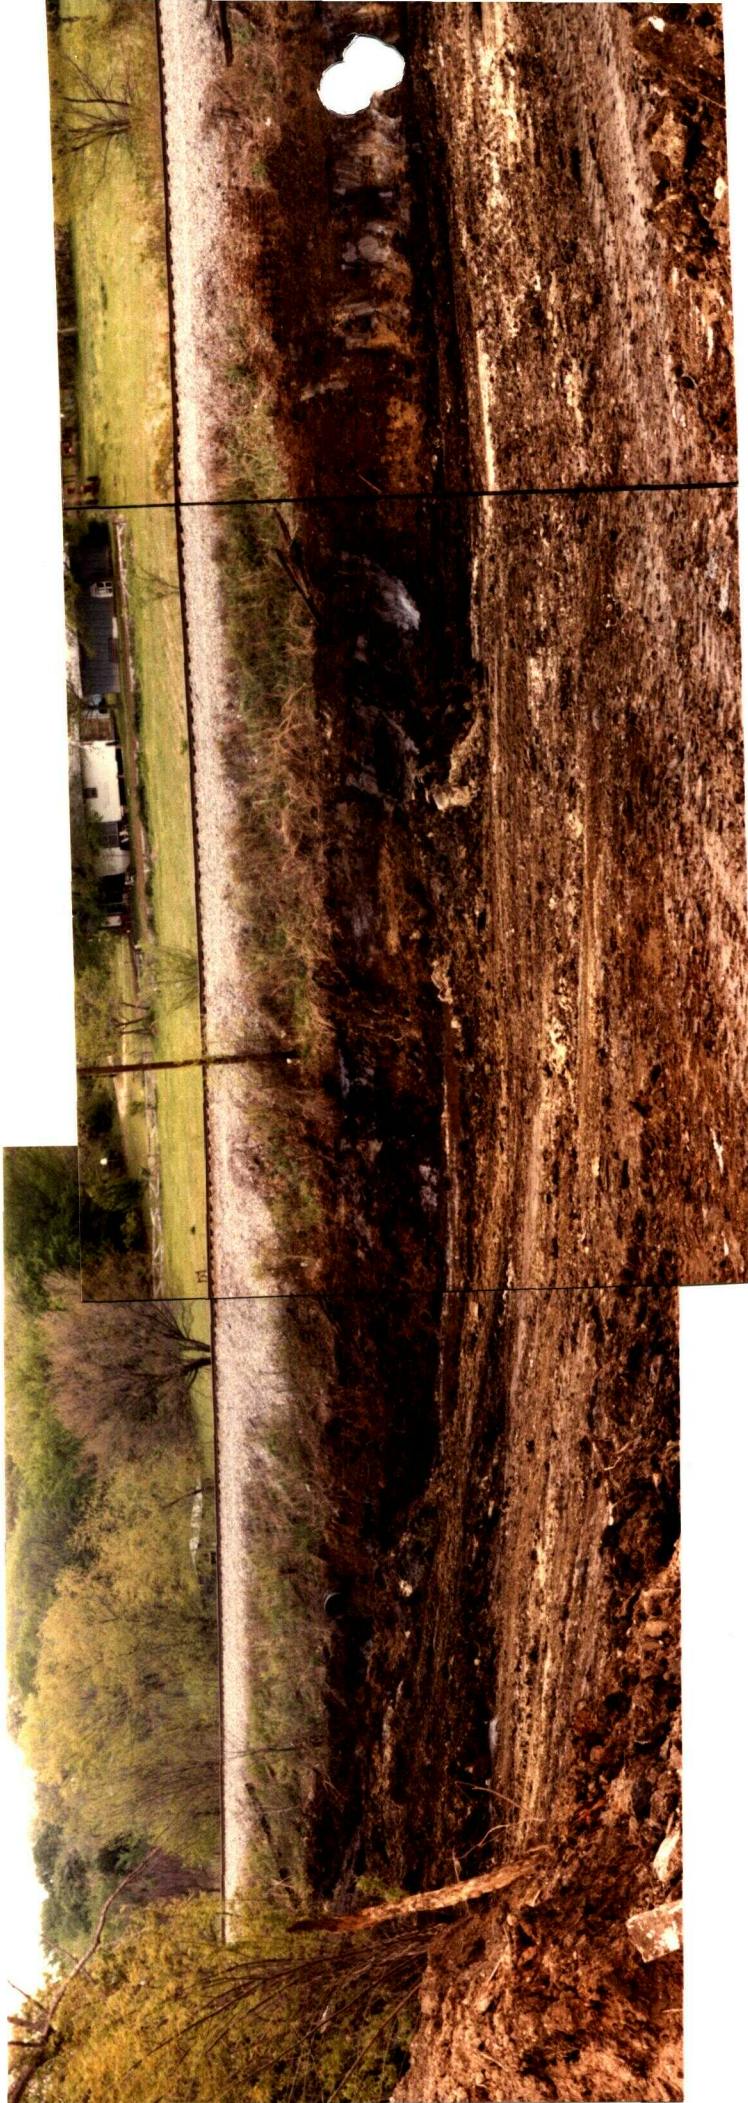
Photographer/Witness # 9

Comments: NORTH HALF OF

PANORAMA SHOWING EXTENSIVE

REMOVAL OF SUBSURFACE

CONTAMINATION AT PROJECT THREE

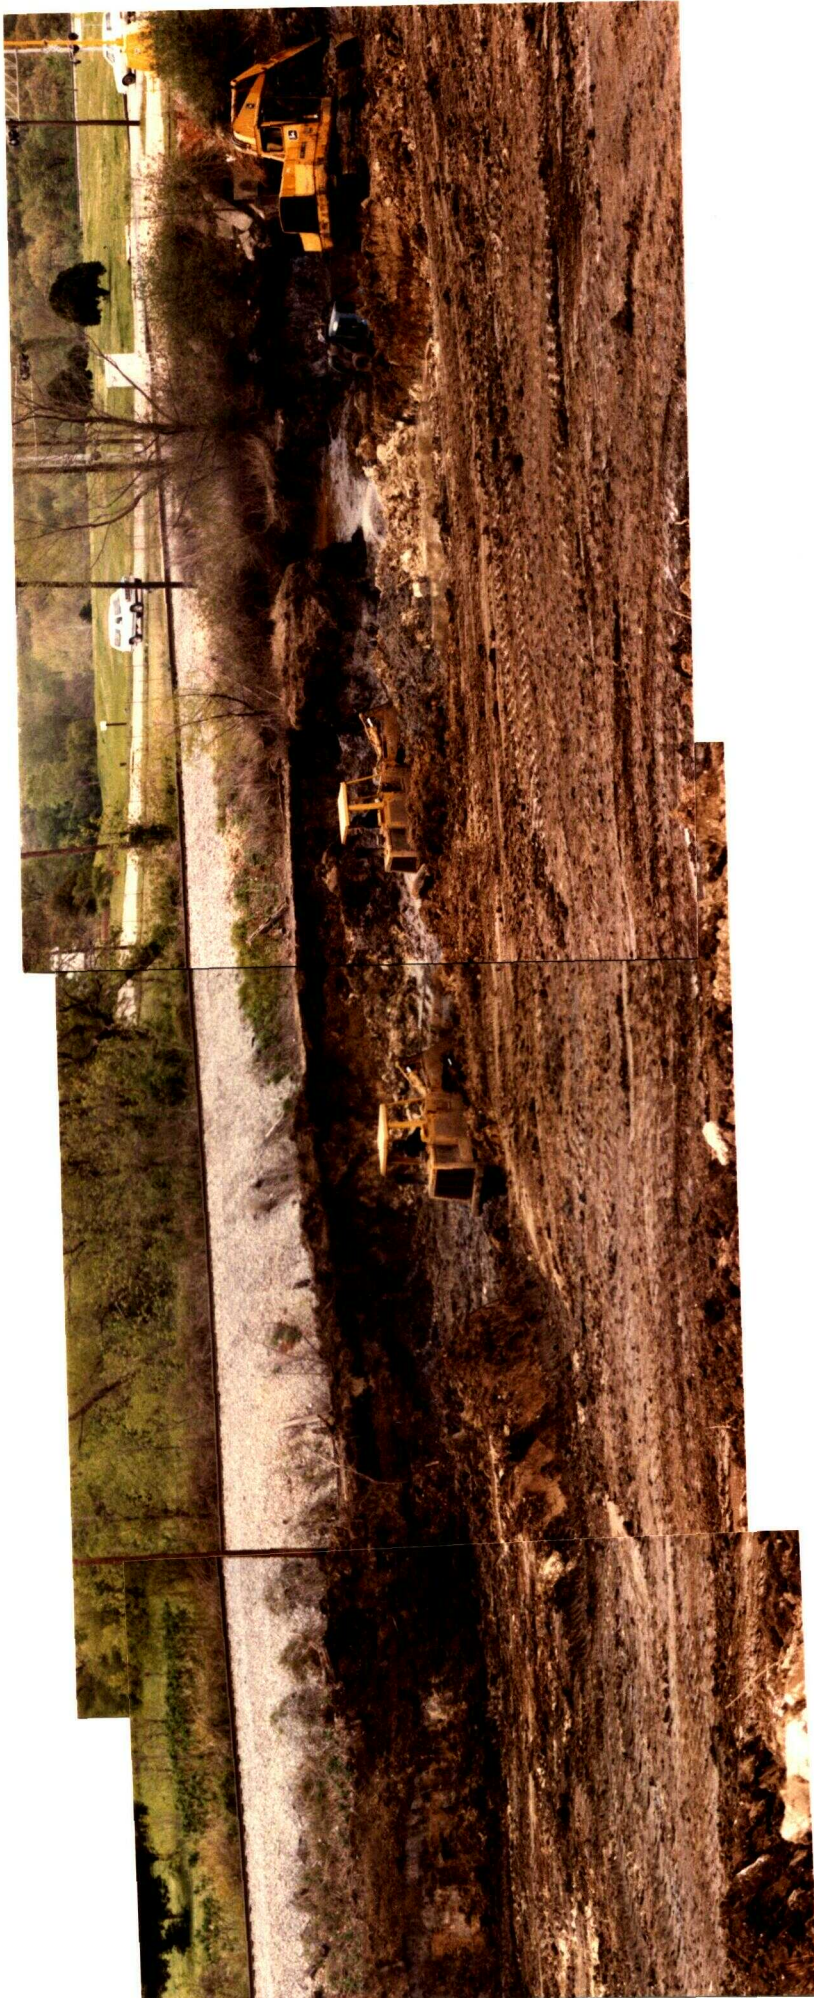
Photographer/Witness # 10

Comments: SOUTH HALF OF

PANORAMA SHOWING EXTENSIVE

REMOVAL OF SUBSURFACE

CONTAMINATION AT PROJECT THR
